Container, Underwater
Storage
EB 177A

PANEL

TESTS

This letter report summarizes the results of the inspection of the unpainted-metal test panels which were immersed in sea water at Daytona Beach, for 12 months, during the period from February, 1956, to April, 1957, in connection with Research Order No. 16. The four- and six-month inspection data on these panels were described in our letter report dated September 20, 1956.

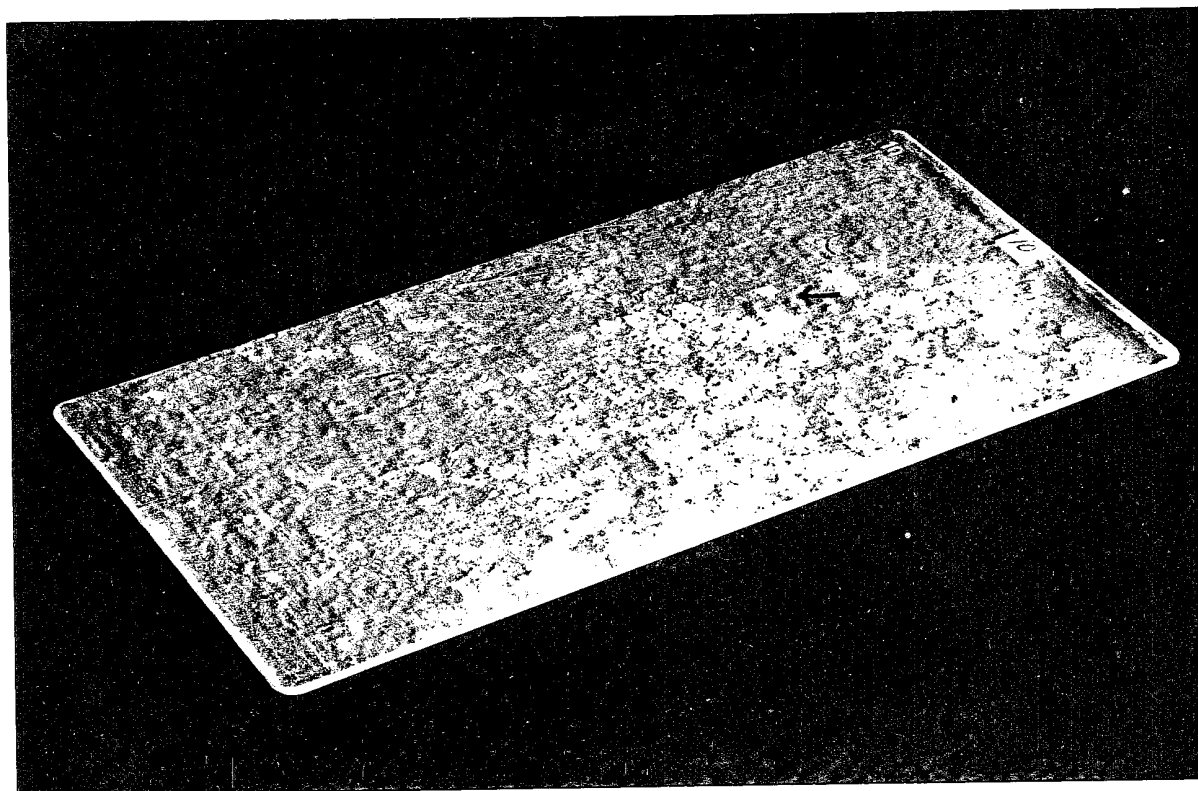
Figure 1. Front Side of Bare Type 52S Panel (No. 10) -
12 Months of Sea-Water Immersion

Light spot shown by arrow is area of deepest
corrosion penetration - approximately
0.004 inch deep.

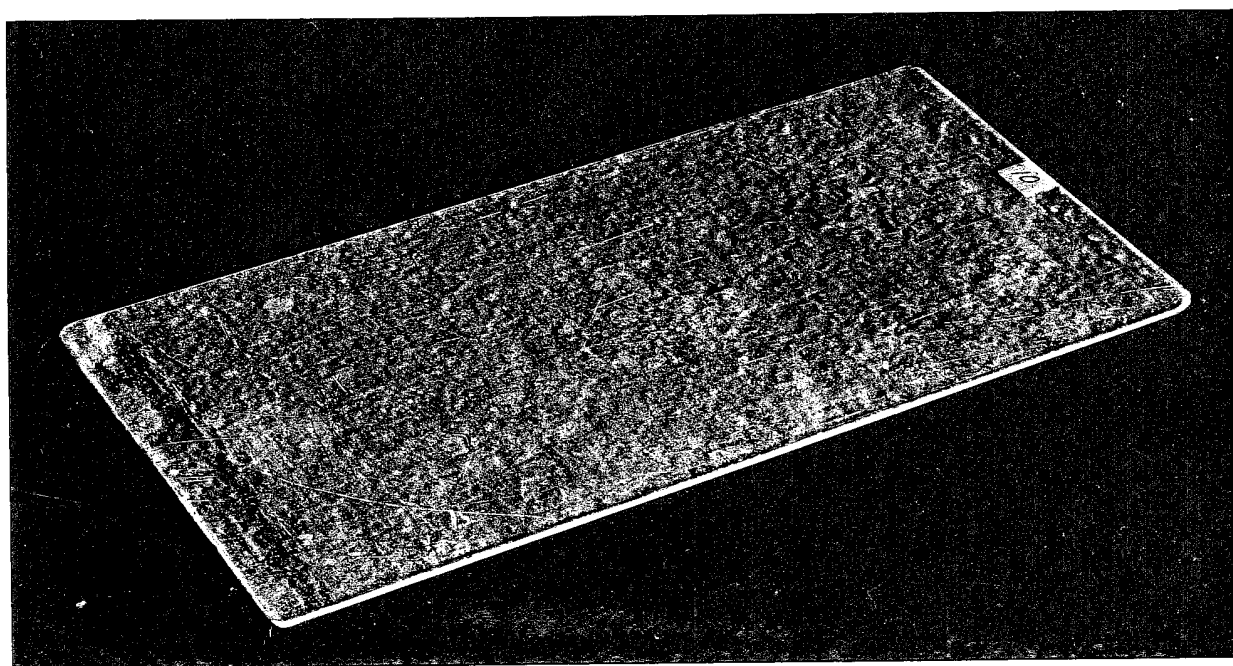
Figure 2. Back Side of Bare Type 52S Panel (No. 10) -
12 Months of Sea-Water Immersion

Scattered very light areas are minor pinhole
pits.

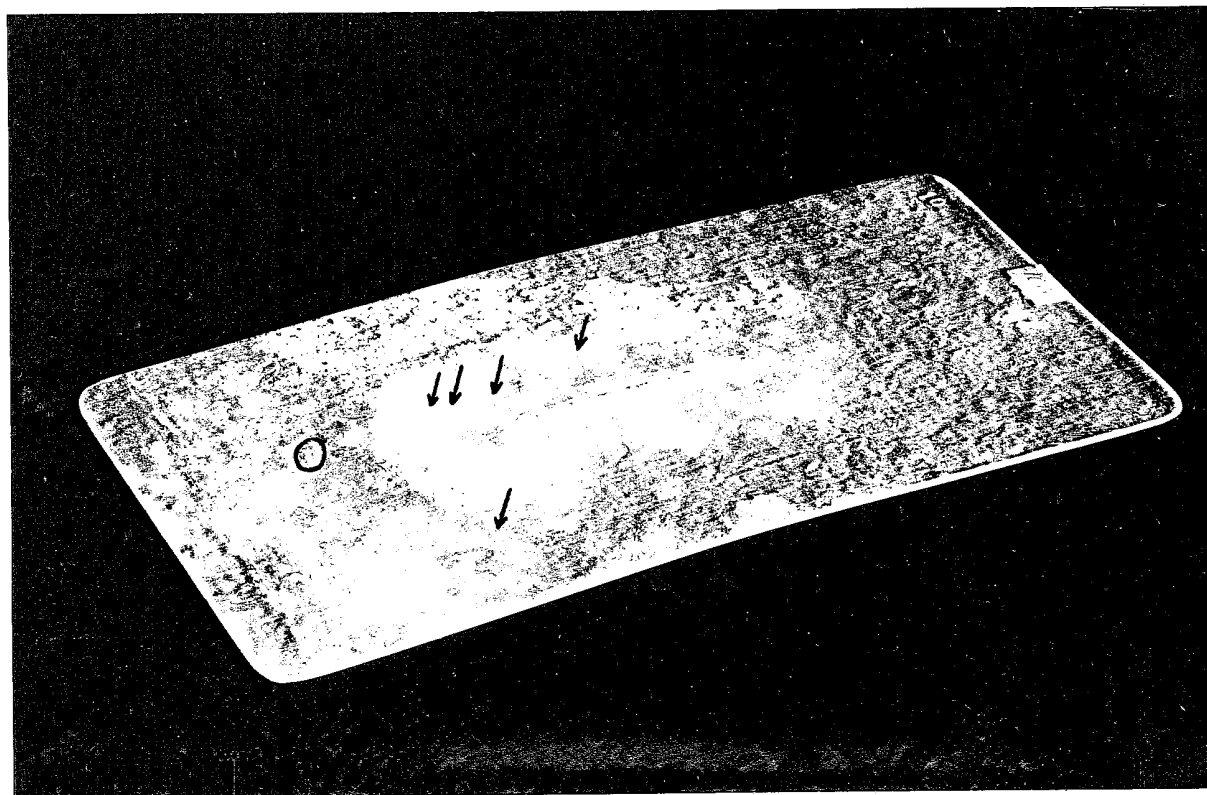
Figure 3. Front Side of Bare Type 52S Panel With Weld Bead (No. 10W) - 12 Months of Sea-Water Immersion

Light areas shown by arrows are shallow corrosion pits. (Circled area is scratch in the metal.)

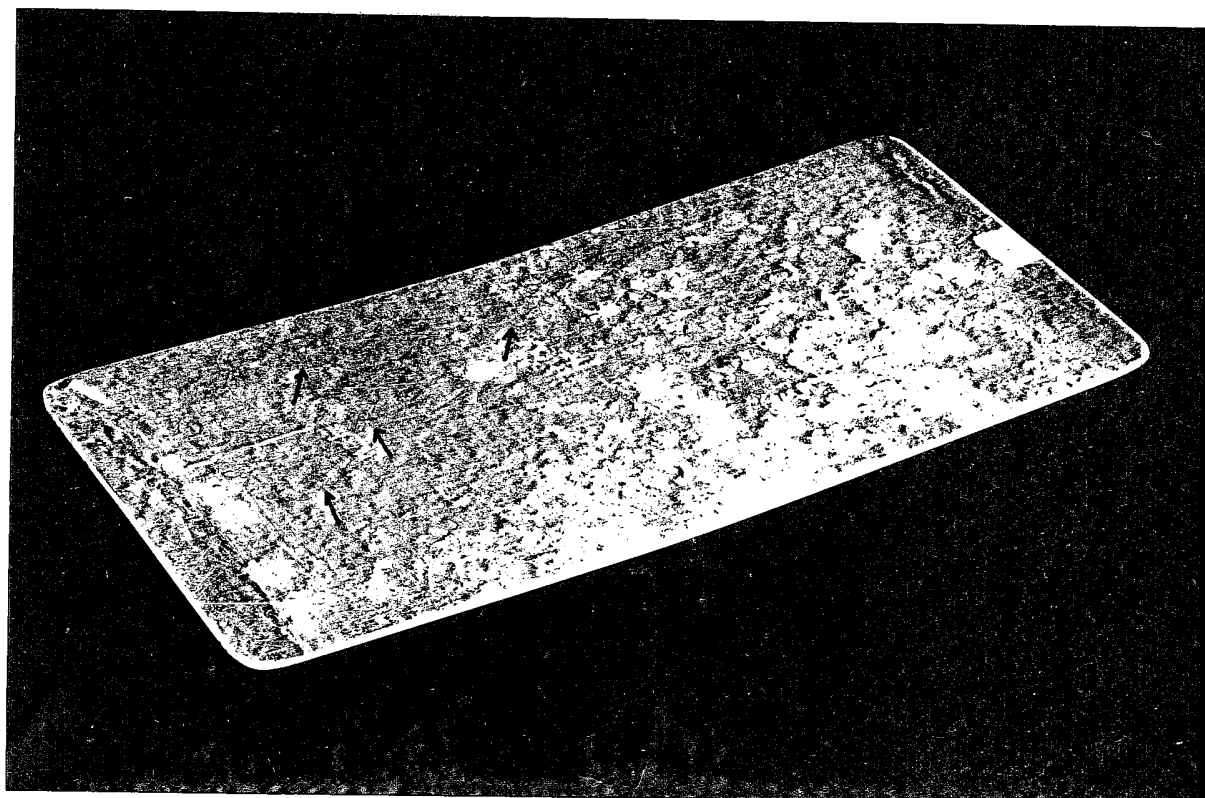
Figure 4. Back Side of Bare Type 52S Panel With Weld Bead
(No. 10W) - 12 Months of Sea-Water Immersion

Pitting is very minor. A few pinpoint pits are
indicated by arrows.

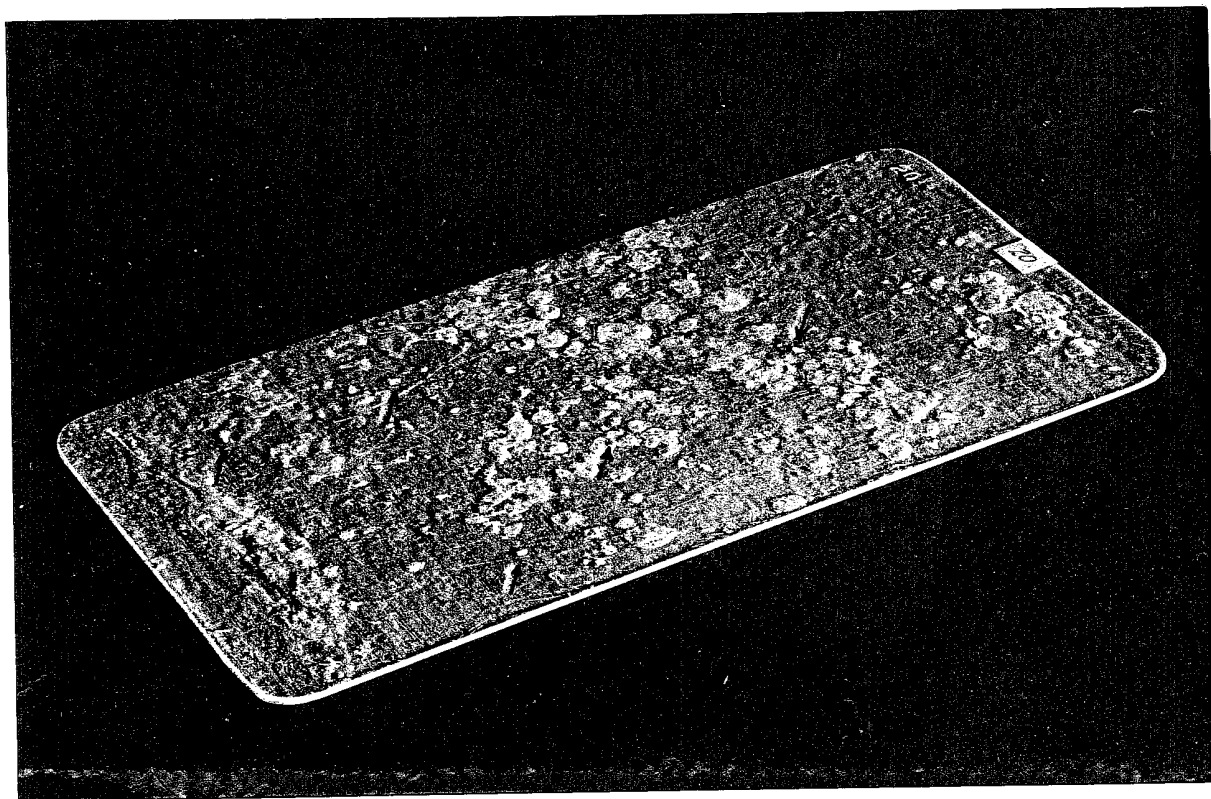
Figure 5. Front Side of Anodized Type 52S Panel (No. 20) -
12 Months of Sea-Water Immersion

Major pits are indicated by arrows -
maximum depth 0.004 inch.

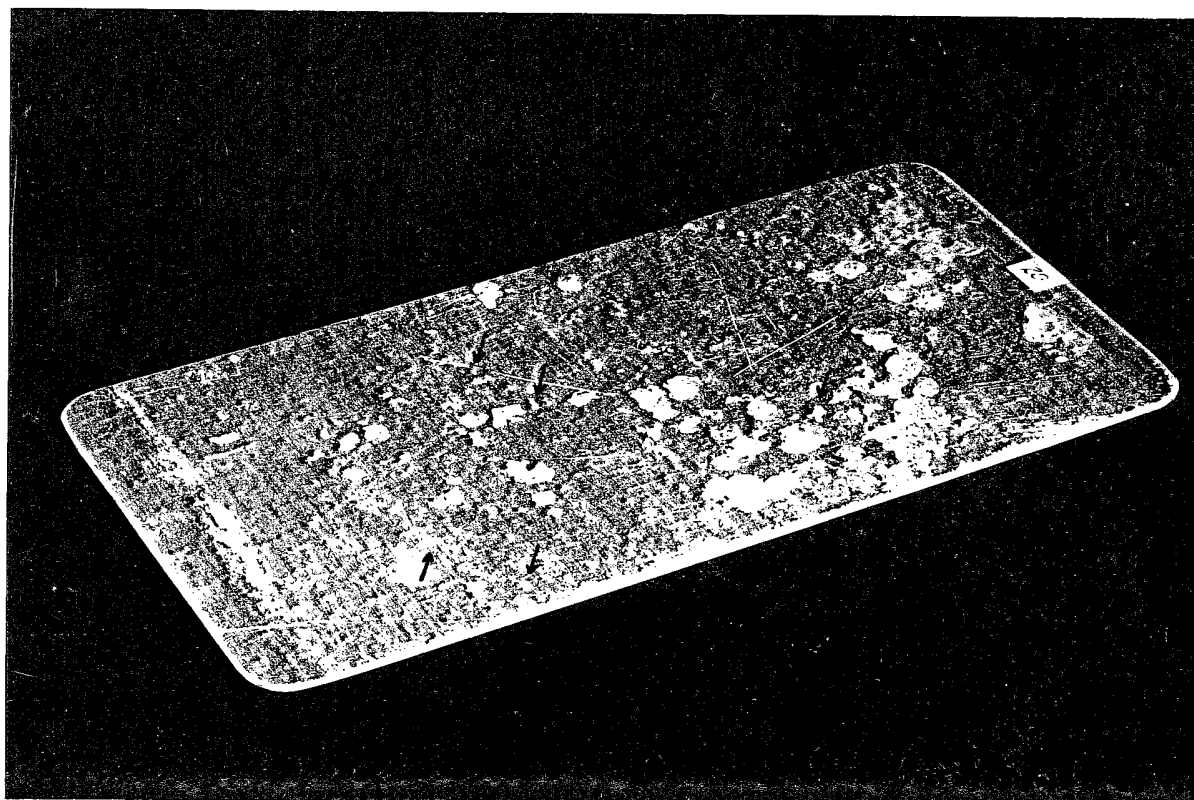
Figure 6. Back Side of Anodized Type 52S Panel (No. 20) -
12 Months of Sea-Water Immersion

Major pits are indicated by arrows - maximum
depth 0.004 inch.

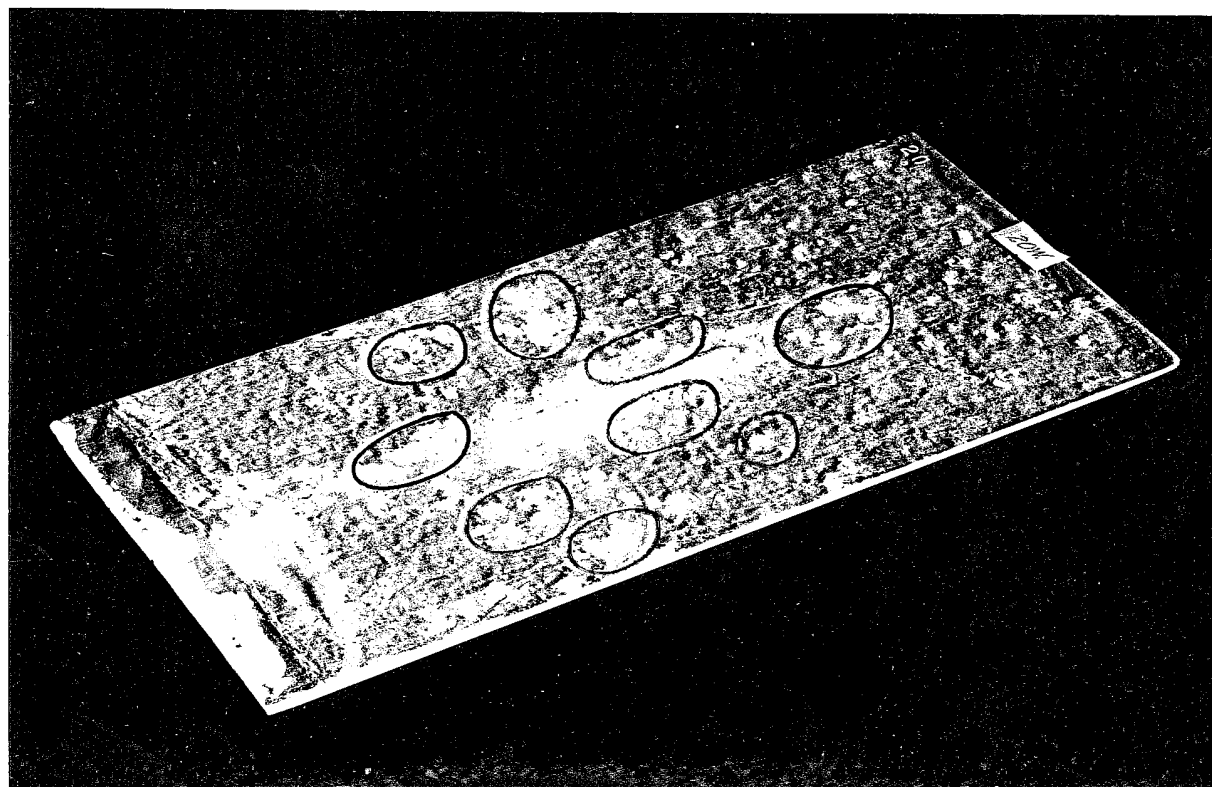
Figure 7. Front Side of Anodized Type 52S Panel With Weld Bead (No. 20W) - 12 Months of Sea-Water Immersion

Panel is badly pitted in areas indicated by circles. Maximum pit depth is 0.031 inch.

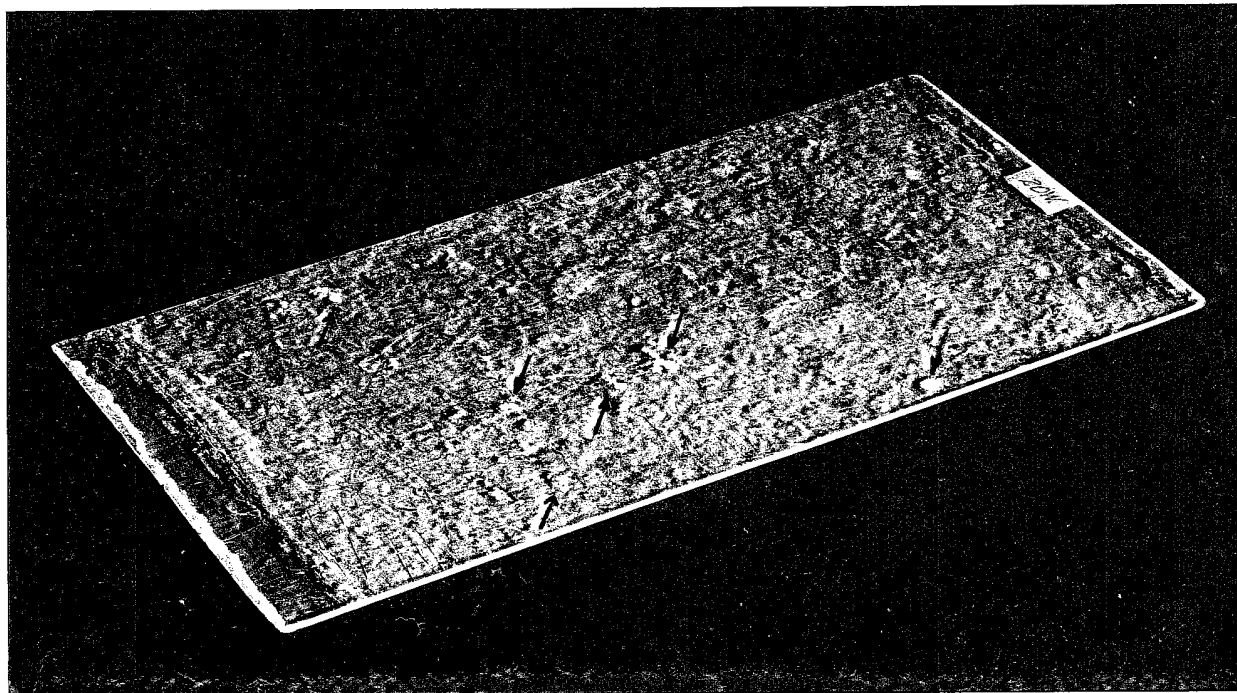
Figure 8. Back Side of Anodized Type 52S Panel With
Weld Bead (No. 20W) - 12 Months of Sea-
Water Immersion

Arrows indicate major pits - 0.004 to
0.031 inch deep.

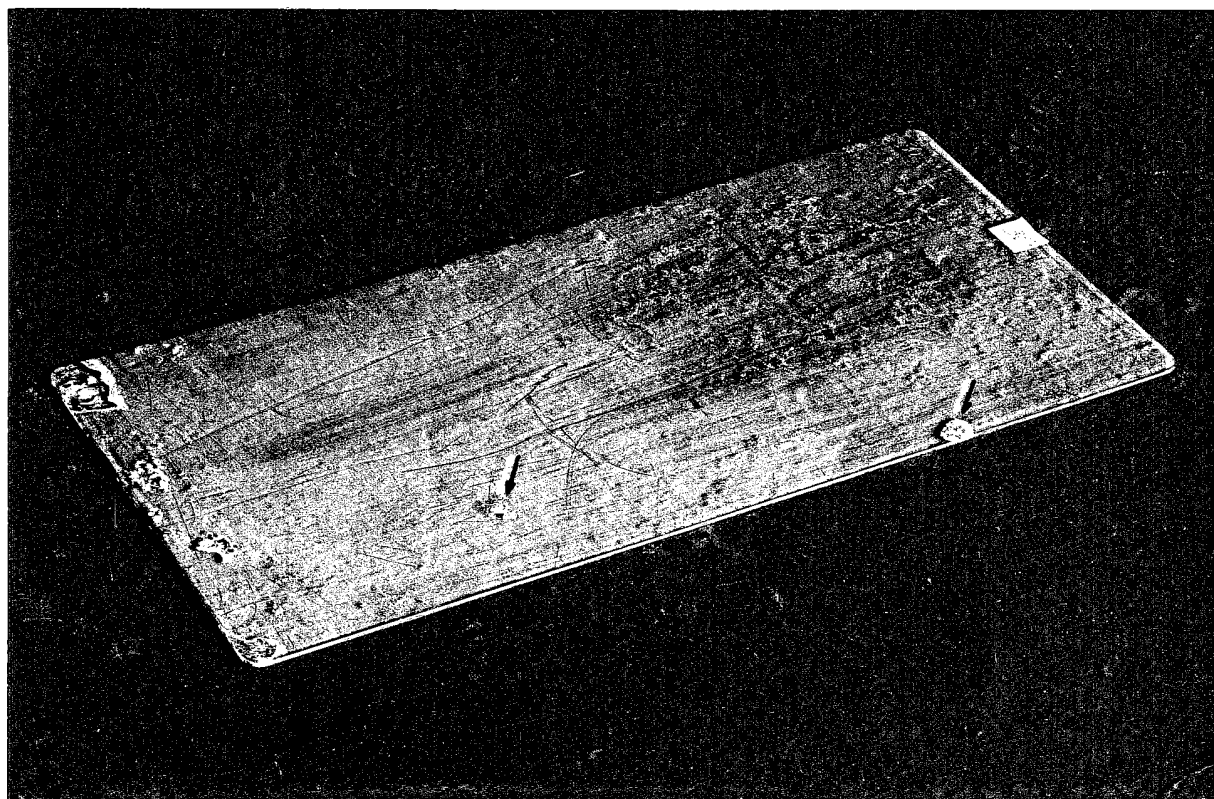
Figure 9. Front Side of Type 316 Panel (No. 30) -
12 Months of Sea-Water Immersion

Two major pits were noted and are indicated by arrows. Mass of pinhole pits, in a pattern, is evident on right half of panel.

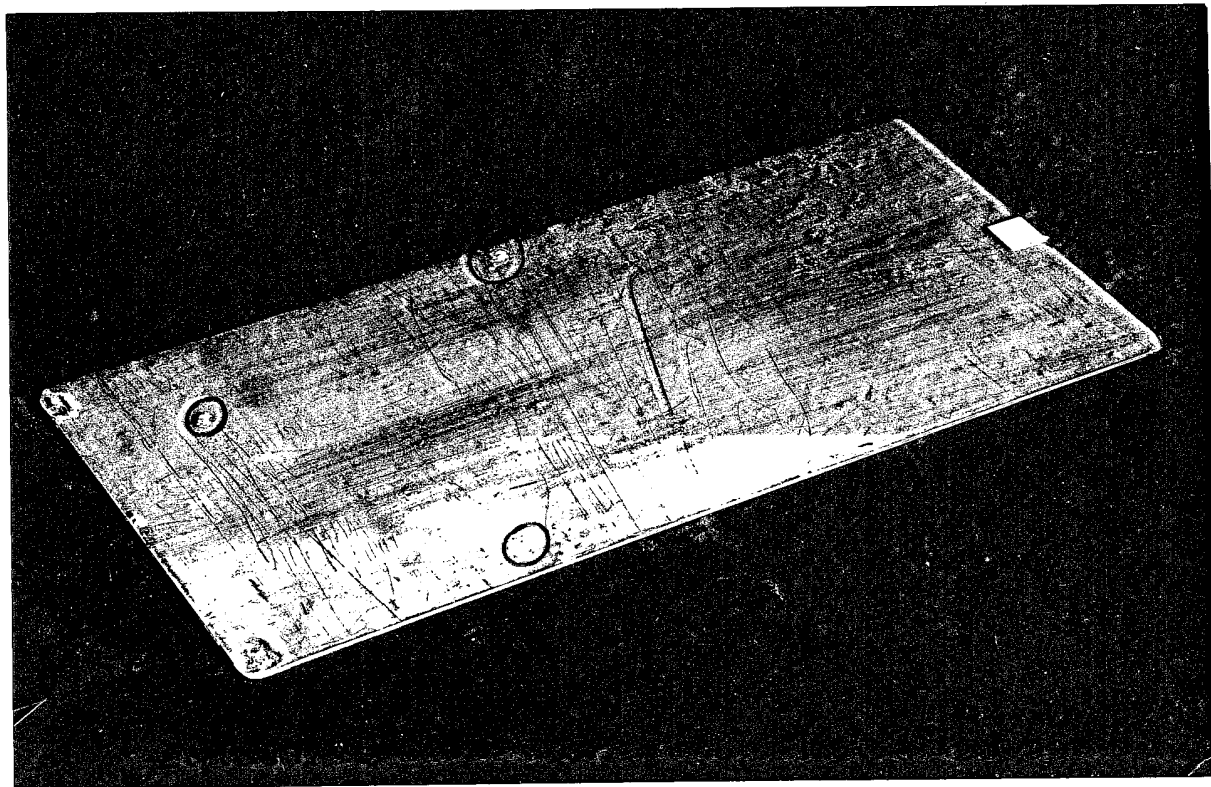
Figure 10. Back Side of Type 316 Panel (No. 30) -
12 Months of Sea-Water Immersion

Three major pits are circled. A number
of pinhole pits are evident at top of
panel, along far edge. Major pits are
0.019 to 0.032 inch deep.

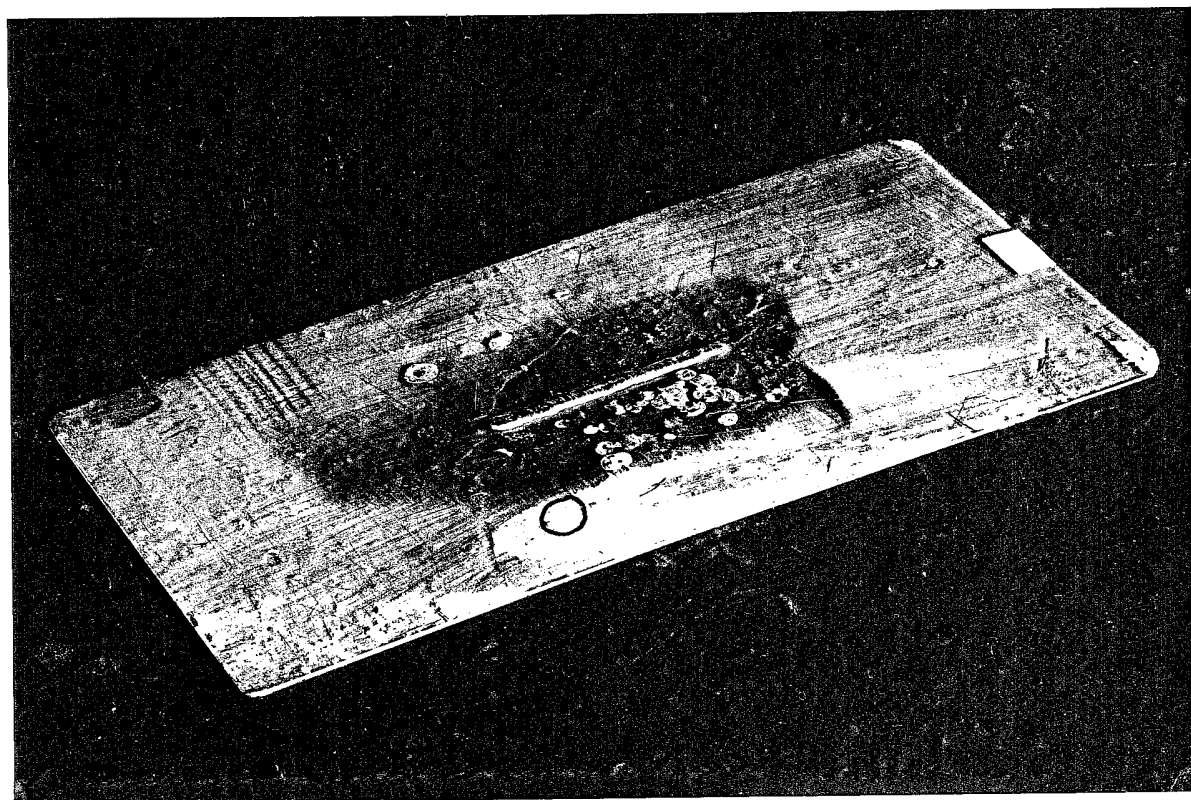
Figure 11. Front Side of Type 316 Panel With Weld Bead
(No. 30W) - 12 Months of Sea-Water Immersion

Circled pit is 0.015 inch deep. Other pits
are from 0.0005 to 0.0025 inch deep.

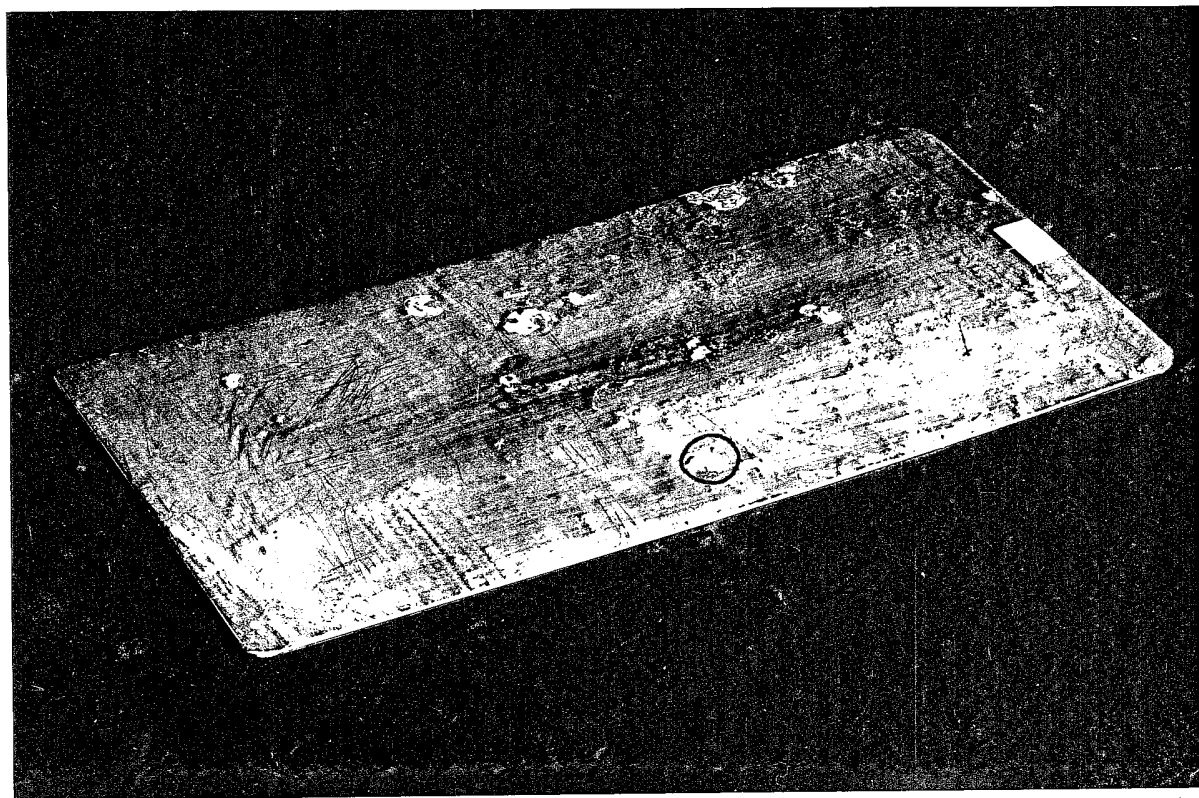
Figure 12. Back Side of Type 316 Panel With
Weld Bead (No. 30W) - 12 Months of
Sea-Water Immersion

Circled pit is 0.060 inch deep - almost
through panel. Other pits are 0.001 to
0.010 inch deep.

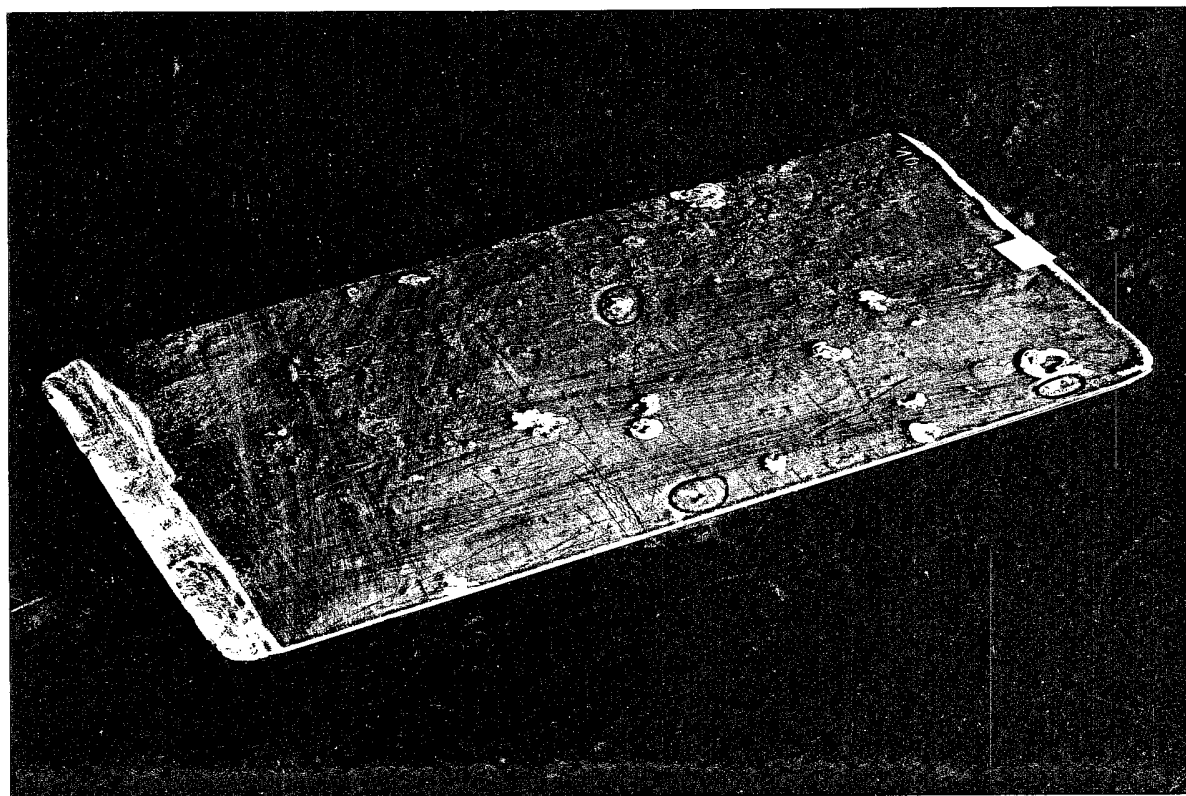
Figure 13. Front Side of Type 304 Panel (No. 40) -
12 Months of Sea-Water Immersion

40W	Type 304 with weld bead	Similar to No. 40; four areas of etching and pitting noted; weld generally intact.
50	Monel	Fouling relatively light; numerous spots of green corrosion product scattered over entire panel, with deep pits under most of these spots; severe pitting throughout.
50W	Monel with weld bead	Similar to No. 50; severe pitting also noted on and around lower half of weld.

Circled areas show pitting that perforated the panel. In other areas pits are 0.008 to 0.056 inch deep. Note also a number of pinhole pits.

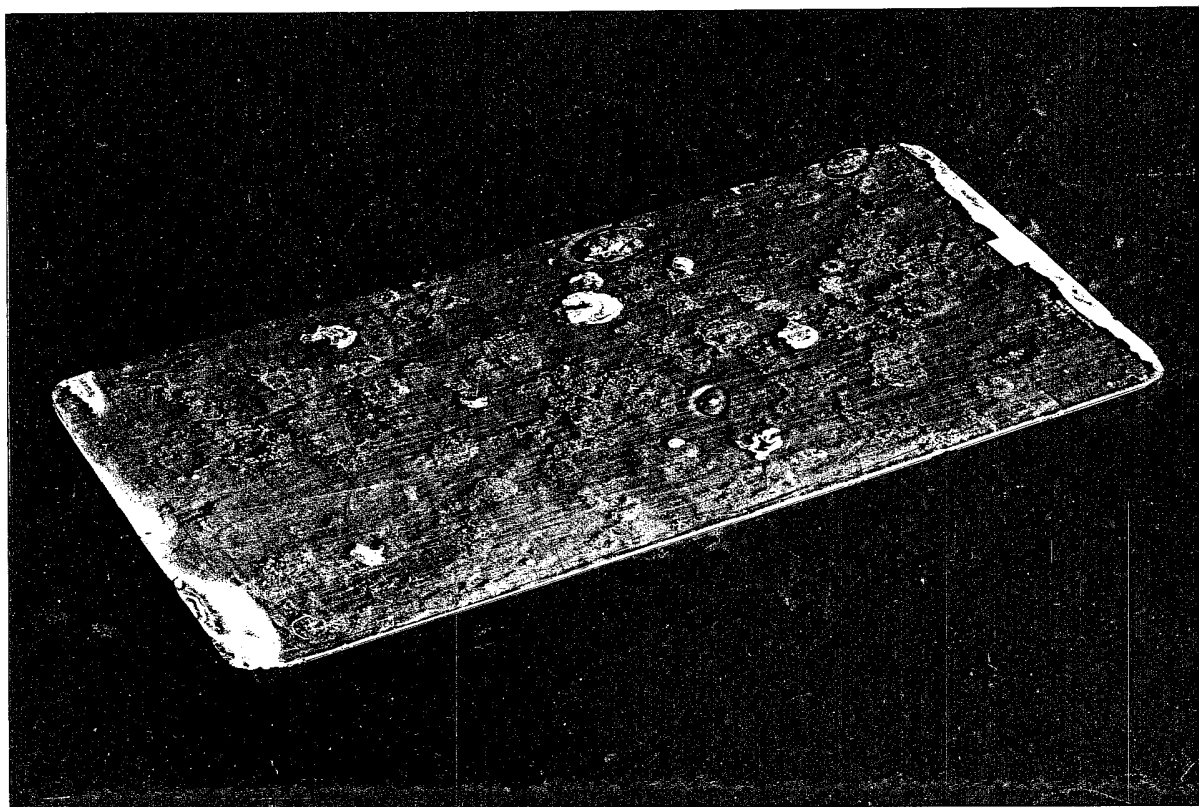
Figure 14. Back Side of Type 304 Panel (No. 40) -
12 Months of Sea-Water Immersion

A few pits, in circled areas, perforated the panel. Other pits are 0.008 to 0.056 inch deep.

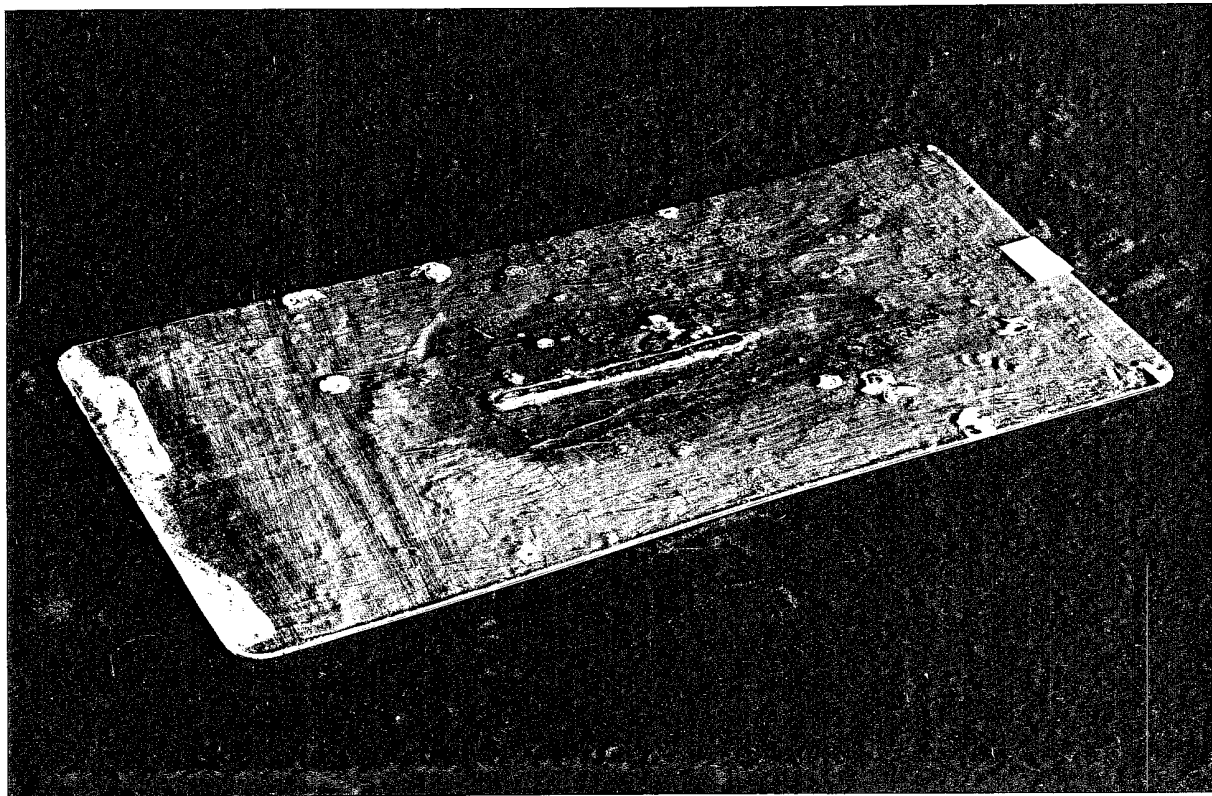
Figure 15. Front Side of Type 304 Panel With Weld Bead
(No. 40W) - 12 Months of Sea-Water Immersion

One pit, in circled area, perforated the
panel. Other pits are 0.004 to 0.042 inch deep.

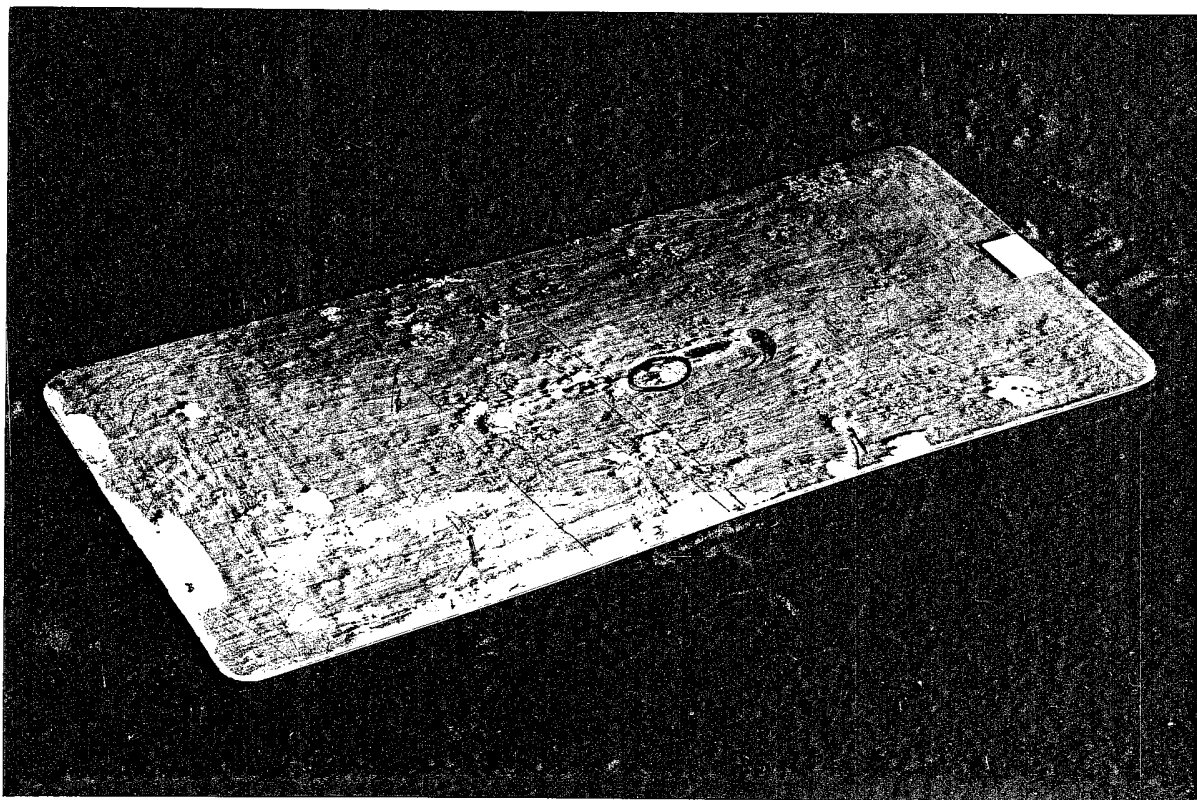
Figure 16. Back Side of Type 304 Panel With Weld Bead
(No. 4OW) - 12 Months of Sea-Water Immersion

One pit, in circled area, perforated the
panel. Other pits are 0.004 to 0.042 inch
deep.

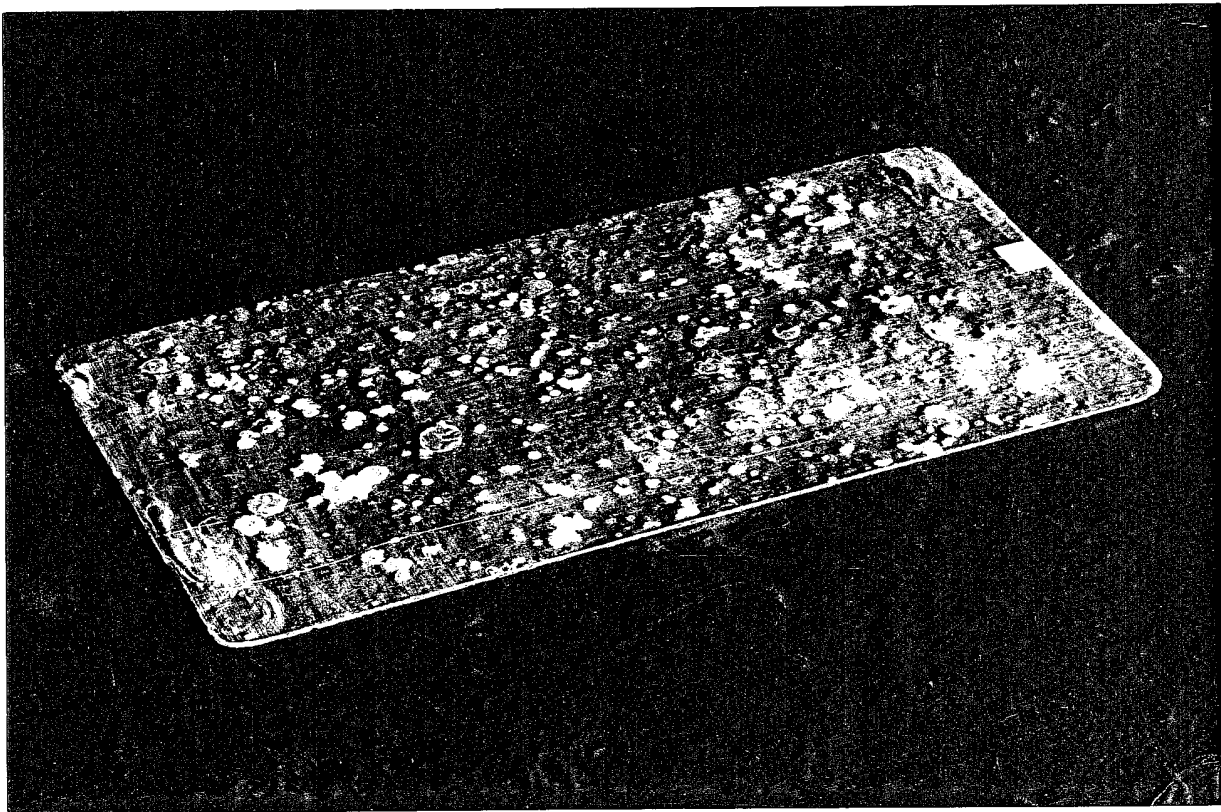
Figure 17. Front Side of Monel Panel (No. 50) -
12 Months of Sea-Water Immersion

This panel is almost completely pitted.

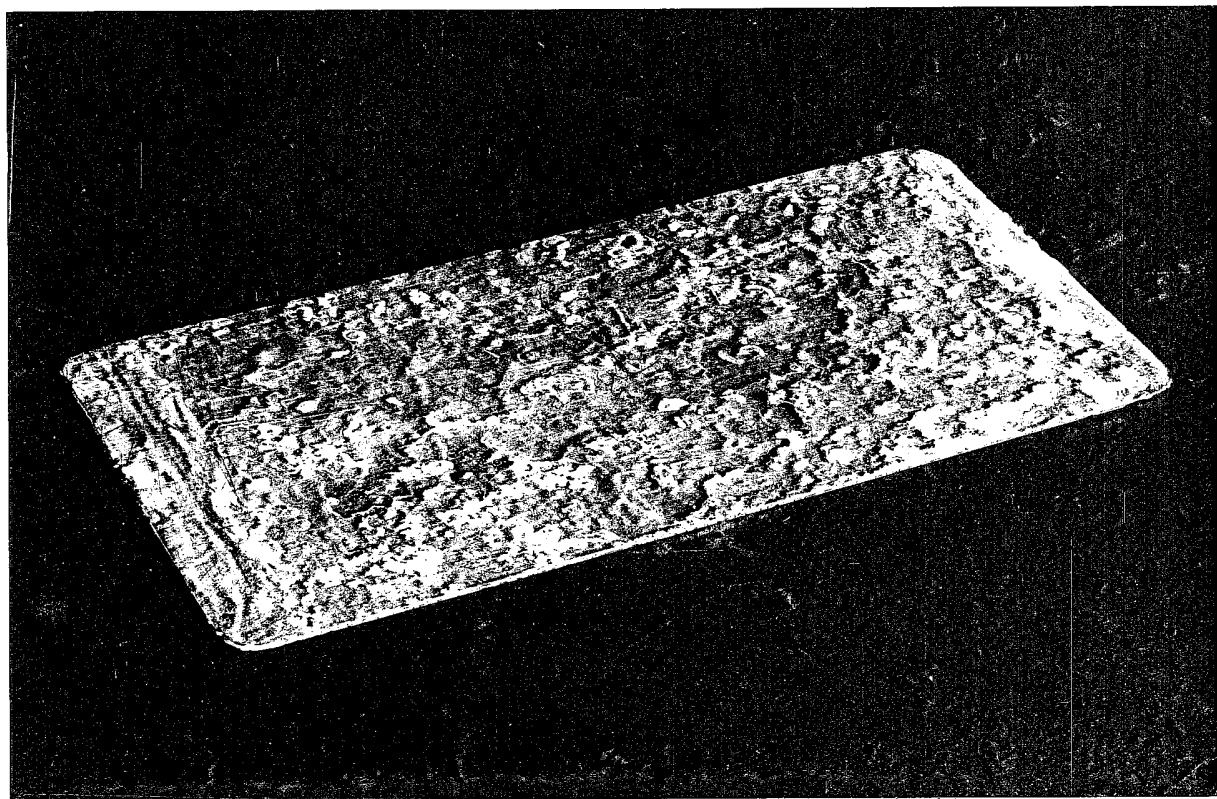
Figure 18. Back Side of Monel Panel -
12 Months of Sea-Water Immersion

This panel is almost completely
pitted.

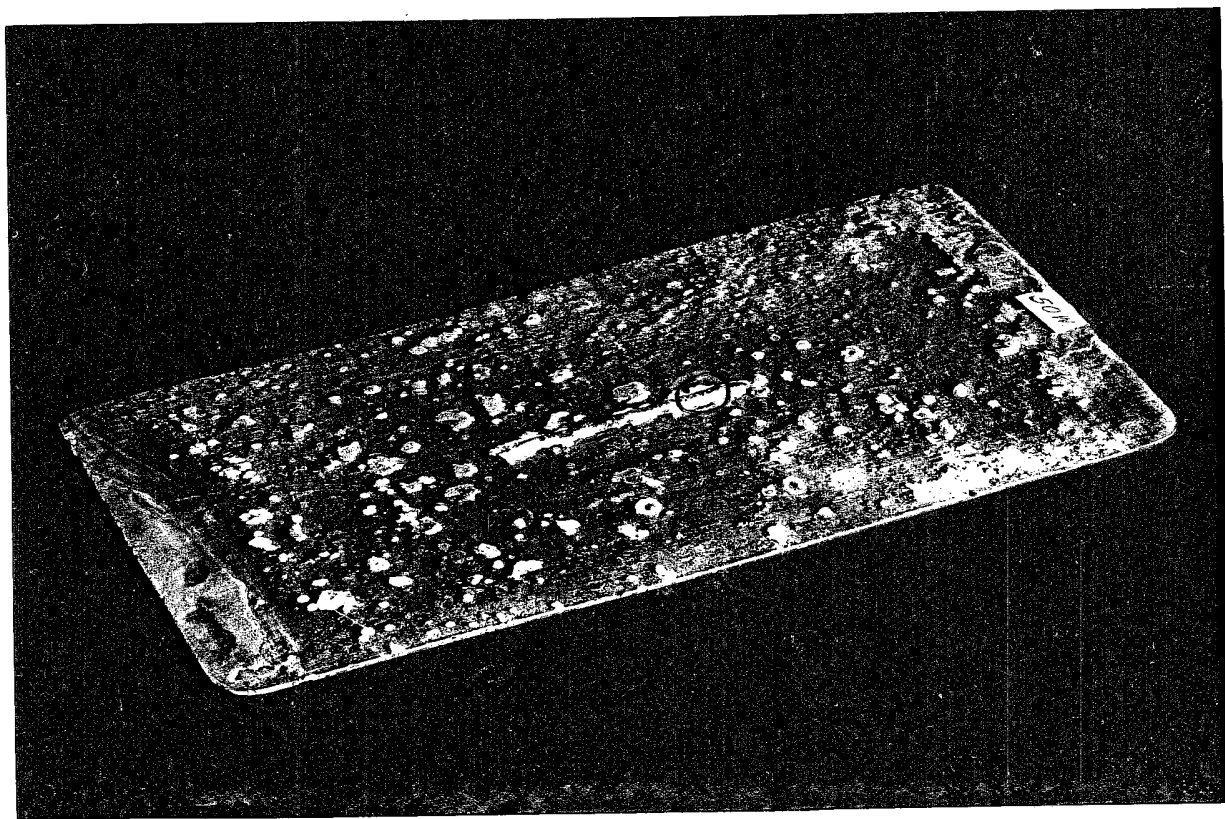
Figure 19. Front Side of Monel Panel With Weld Bead (No. 50W) -
12 Months of Sea-Water Immersion

50W	Monel with weld bead	Same as No. 50.
60	Titanium	No sign of any corrosion damage.
60W	Titanium with weld bead	No sign of any corrosion damage.
-	Cast 43	Only minor pitting.

Circled area is pitted completely through panel.
Remainder of panel is very badly pitted.

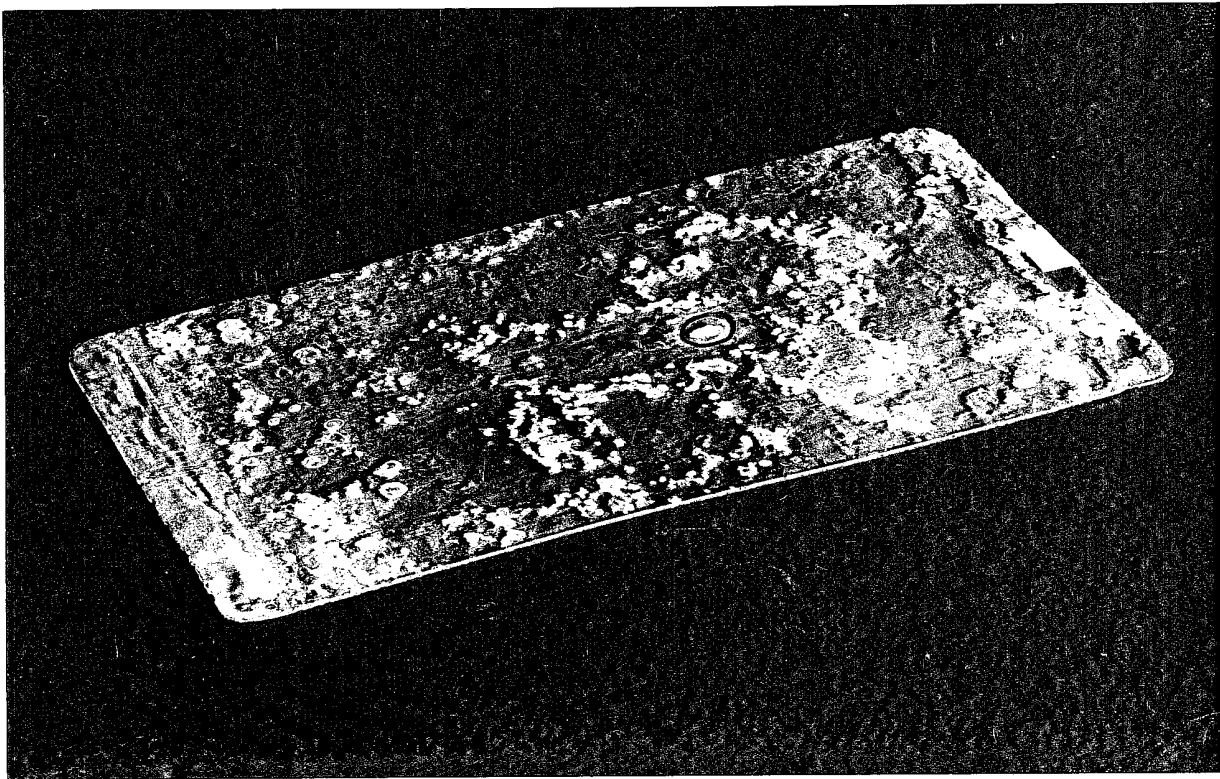
Figure 20. Back Side of Monel Panel With Weld Bead
(No. 50W) - 12 Months of Sea-Water Immersion

In circled area, penetration is completely
through panel. Remainder of panel is
badly pitted.

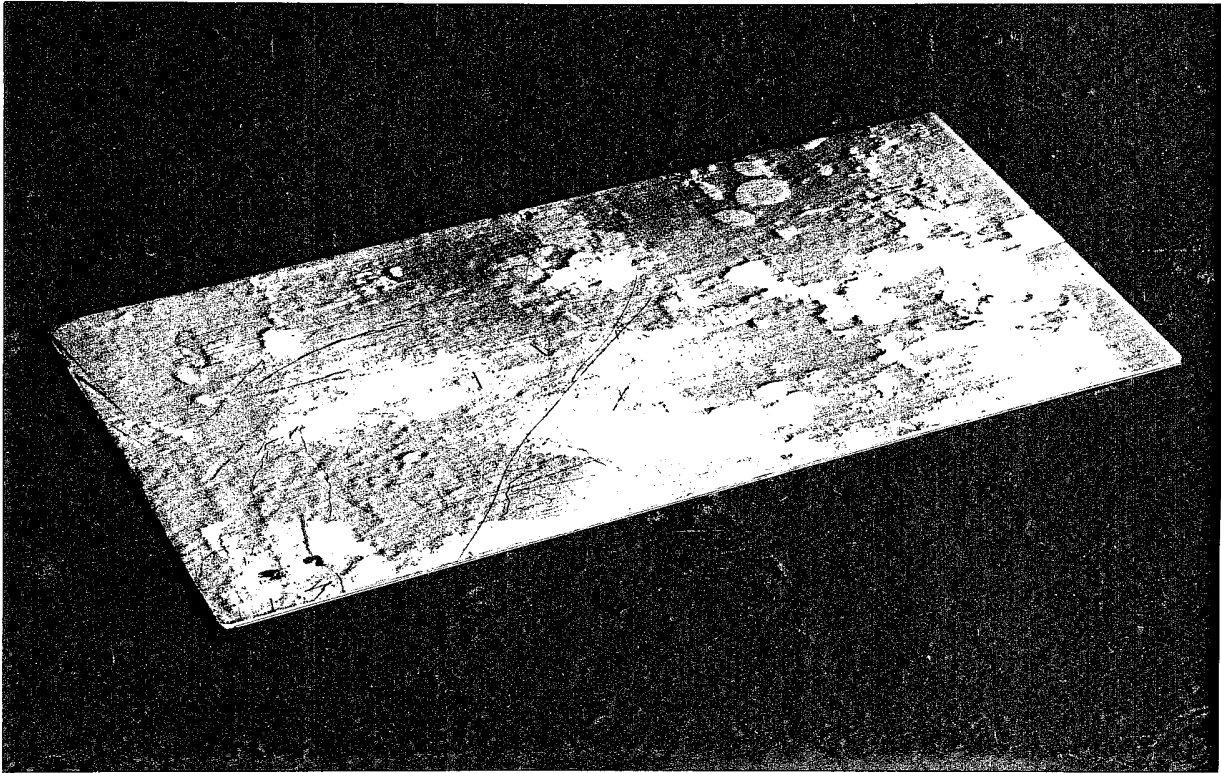
Figure 21. Front Side of Titanium Panel (No. 60) -
12 Months of Sea-Water Immersion

Light spots are areas where marine growth
was attached. No evidence of corrosion
on any part of panel.

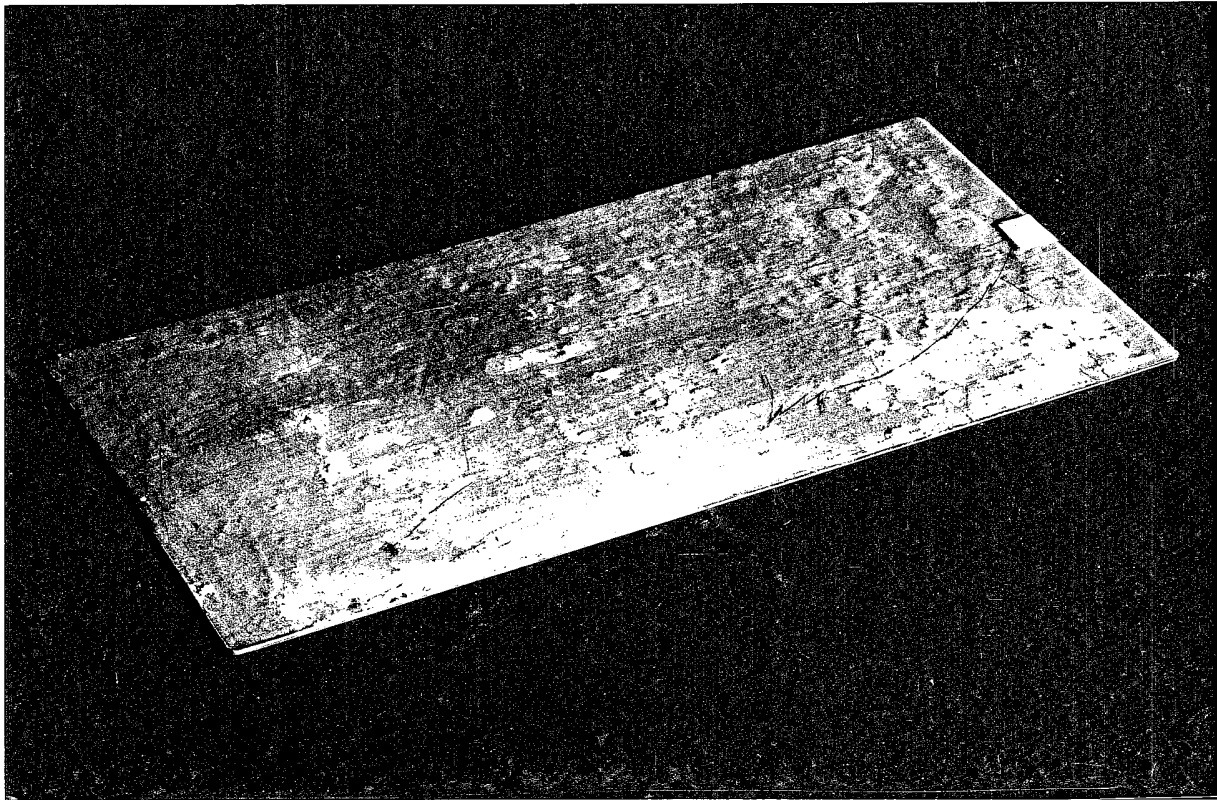
Figure 22. Back Side of Titanium Panel (No. 60) -
12 Months of Sea-Water Immersion

Light spots are areas where marine growth
was attached. No evidence of corrosion on
any part of panel.

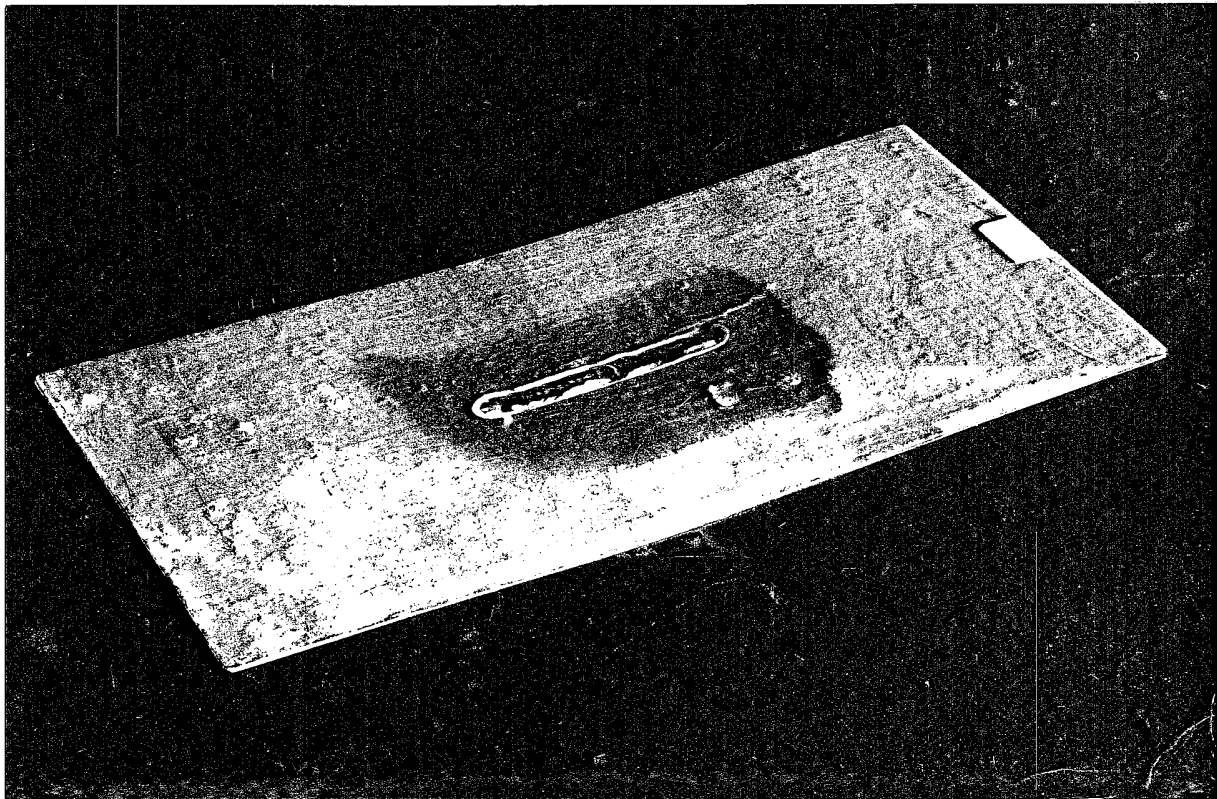
Figure 23. Front Side of Titanium Panel With Weld Bead
(No. 60W) - 12 Months of Sea-Water Immersion

No evidence of corrosion was noted.
